**Flood Control Project Maintenance
Levee Inspections**

Maintenance Issue Types Only, Levee Inspection Report By Mile - Spring 2016

Sutter Maintenance Yard Wadsworth Canal

Waterway	Bank	Unit Miles	Inspection Start/End	Inspector
Unit No. 01 Wadsworth Canal	Left	4.63	03/17/2016 03/17/2016	Keith Millard

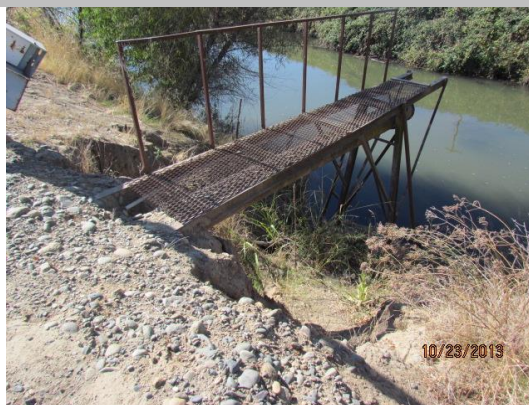
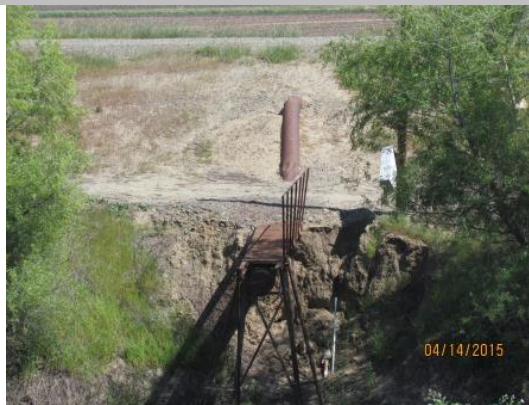
LM Start	1.85	Rating **	U	Issue No.	107
LM End	1.85	Issue Type +	Ma	Location *	WS
Category	Earthen Levee			GPS Latitude/Longitude	
				Start	End
Item	Erosion / Bank Caving			39.135110 °	39.135110 °
				-121.748230 °	-121.748230 °
DWR ID	DWR_ST0010_01_f_2013_107				
Comment Code					
E2 : Schedule repair of erosion site prior to the next inspection.					
Inspector Comment					
Repair the erosion under the abandoned pump.

View of the erosion along both sides of the abandoned pump.

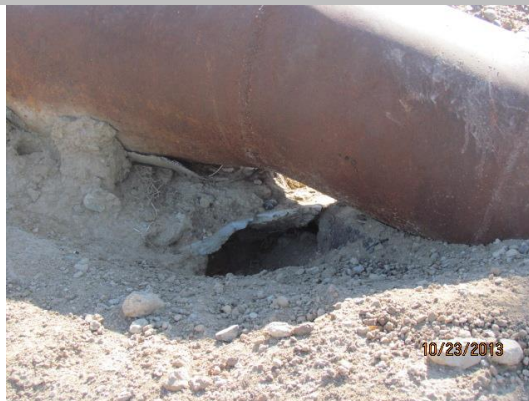
Photo 1 of 1 : SP_2016_ST0010_42_106_20160316_00011.jpg

LM Start	1.85	Rating **	M	Issue No.	106
LM End	1.85	Issue Type +	Ma	Location *	WS
Category	Earthen Levee			GPS Latitude/Longitude	
				Start	End
Item	Animal Control			39.135110 °	39.135110 °
				-121.748229 °	-121.748229 °
DWR ID	DWR_ST0010_01_f_2013_106				
Comment Code					
A3 : No rodents visible, but rodent burrows visible; need to backfill and compact or grout burrows.					
Inspector Comment

View of the rodent holes under the irrigation pipe.

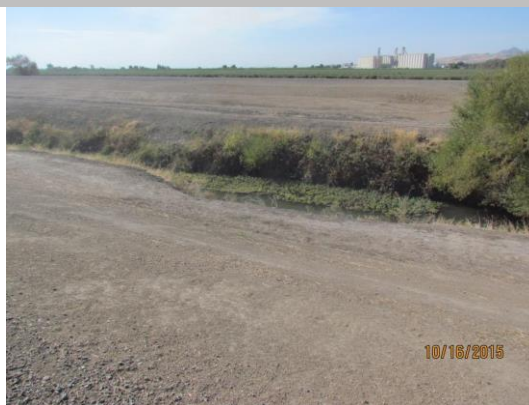
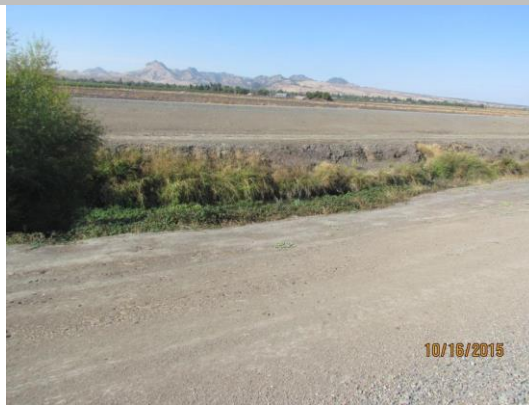
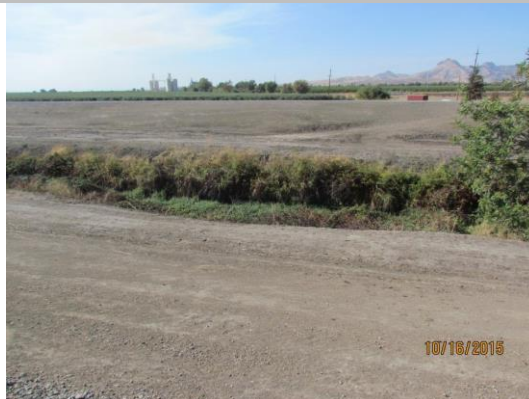
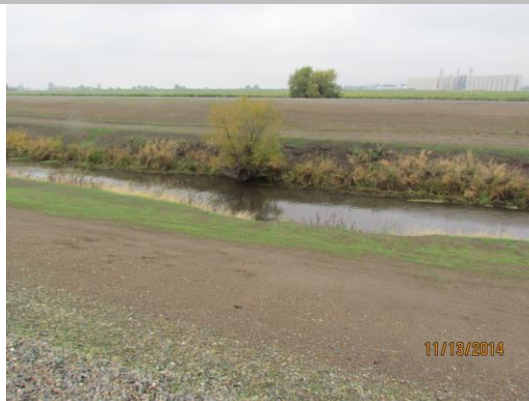
LM Start	2.43	Rating **	M	Issue No.	6
LM End	3.30	Issue Type +	Ma	Location *	WS
Category	Supplemental			GPS Latitude/Longitude	
				Start	End
Item	2015 USACE Erosion Survey, DRAFT			39.142235 °	39.153095 °
				-121.742609 °	-121.734390 °
DWR ID	DWR_ST0010_01_f_2015_6				
Comment Code					
Inspector Comment					
2010 - Over steepened levees, some slumping, reach-wide problem.					
2011 - Still a reach-wide problem. 2015: Site is part of the extended inventory, last inspected 2011. [2015 Site ID: WAD_2-4_L]

View of the erosion along the waterside toe.

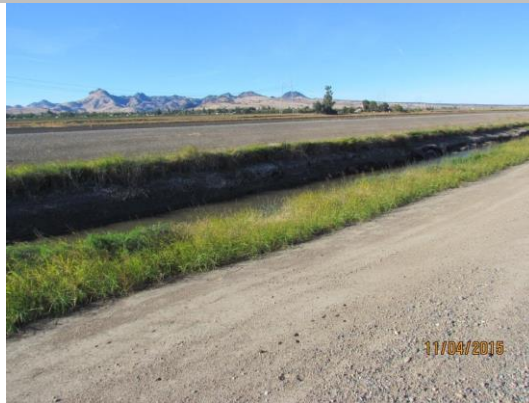
Photo 1 of 1 : SP_2016_ST0010_42_3_20160316_00001.jpg

LM Start	3.53	Rating **	M	Issue No.	3
LM End	3.56	Issue Type +	Ma	Location *	WS
Category	Earthen Levee			GPS Latitude/Longitude	
				Start	End
Item	Erosion / Bank Caving			39.156225 °	39.156639 °
				-121.732930 °	-121.732755 °
DWR ID	DWR_ST0010_01_s_2012_3				
Comment Code					
E1 : Note and monitor erosion site.					
Inspector Comment					
Monitor the erosion along the waterside toe.

View of the erosion along the waterside toe.

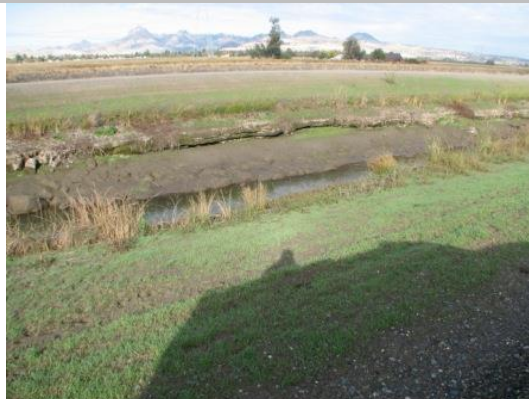
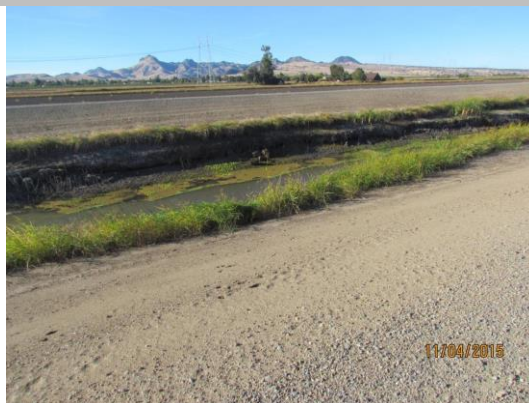
LM Start	3.65	Rating **	M	Issue No.	4
LM End	3.65	Issue Type +	Ma	Location *	WS
Category	Earthen Levee			GPS Latitude/Longitude	
				Start	End
Item	Erosion / Bank Caving			39.157861 °	39.157861 °
				-121.732238 °	-121.732238 °
DWR ID	DWR_ST0010_01_s_2012_4				
Comment Code					
E1 : Note and monitor erosion site.					
Inspector Comment					
Monitor the erosion along the waterside toe.

View of the erosion along the waterside toe of the levee.

View of the erosion along the waterside toe.

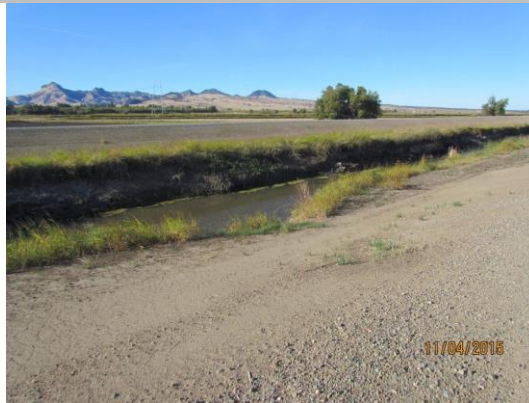
Photo 1 of 1 : SP_2016_ST0010_42_17_20160316_00010.jpg

LM Start	3.84	Rating **	M	Issue No.	17
LM End	3.84	Issue Type +	Ma	Location *	WS
Category	Earthen Levee			GPS Latitude/Longitude	
				Start	End
Item	Erosion / Bank Caving			39.160442 °	39.160442 °
				-121.731067 °	-121.731067 °
DWR ID	DWR_ST0010_01_f_2014_17				
Comment Code					
E1 : Note and monitor erosion site.					
Inspector Comment					
Monitor the erosion along the waterside toe.

View of the erosion along the waterside toe.

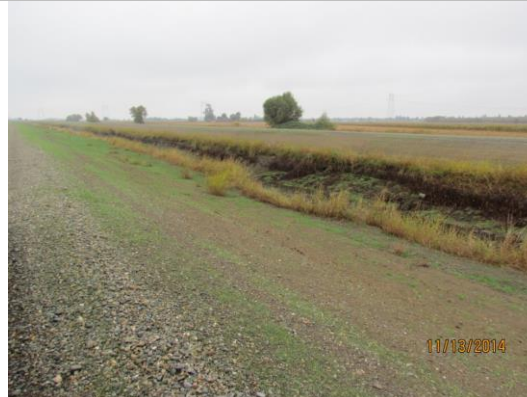
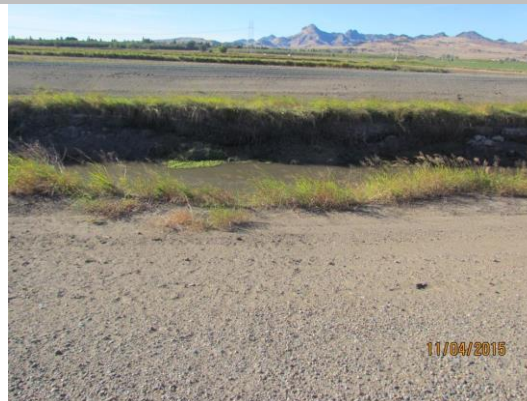
LM Start	4.23	Rating **	M	Issue No.	5
LM End	4.23	Issue Type +	Ma	Location *	WS
Category	Earthen Levee			GPS Latitude/Longitude	
				Start	End
Item	Erosion / Bank Caving			39.165845 °	39.165845 °
				-121.728877 °	-121.728877 °
DWR ID	DWR_ST0010_01_s_2012_5				
Comment Code					
E1 : Note and monitor erosion site.					
Inspector Comment					
Monitor the erosion along the waterside toe.

View of the erosion along the waterside toe.

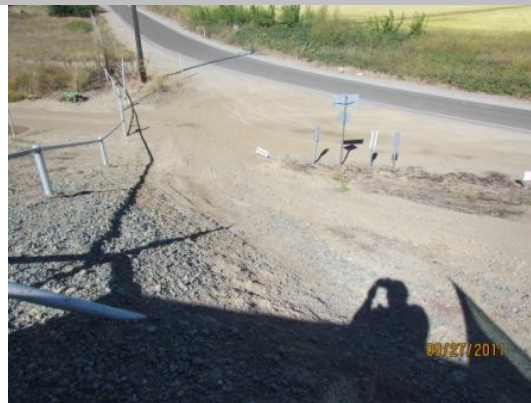
Photo 1 of 1 : SP_2016_ST0010_43_3_20160316_00001.jpg

LM Start	1.17	Rating **	M	Issue No.	3
LM End	1.17	Issue Type +	Ma	Location *	LS
Category	Earthen Levee			GPS Latitude/Longitude	
				Start	End
Item	Slope Stability			39.127648 °	39.127648 °
				-121.756345 °	-121.756345 °
DWR ID	DWR_ST0010_02_s_2012_3				
Comment Code					
S3 : Repair the levee slope damaged by vehicle traffic and prevent access where possible.					
Inspector Comment

View of vehicle erosion along L/S slope.

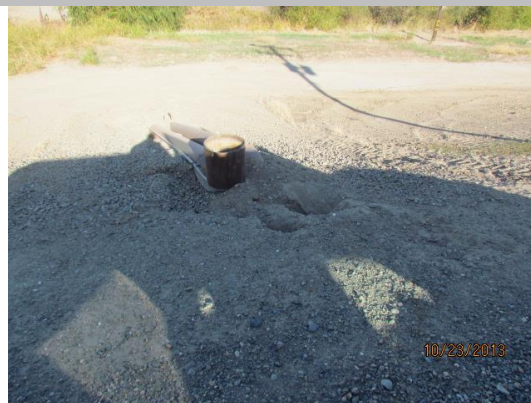
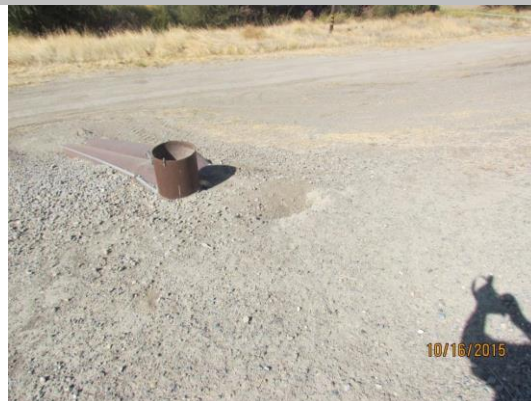
LM Start	1.76	Rating **	M	Issue No.	11
LM End	1.76	Issue Type +	Ma	Location *	LS
Category	Earthen Levee			GPS Latitude/Longitude	
				Start	End
Item	Animal Control			39.134490 °	39.134490 °
				-121.749716 °	-121.749716 °
DWR ID	DWR_ST0010_02_f_2012_11				
Comment Code					
A3 : No rodents visible, but rodent burrows visible; need to backfill and compact or grout burrows.					
Inspector Comment					
Repair the rodent hole.

View of the rodent holes above the irrigation pipe.

View of the rodent hole above the irrigation pipe.

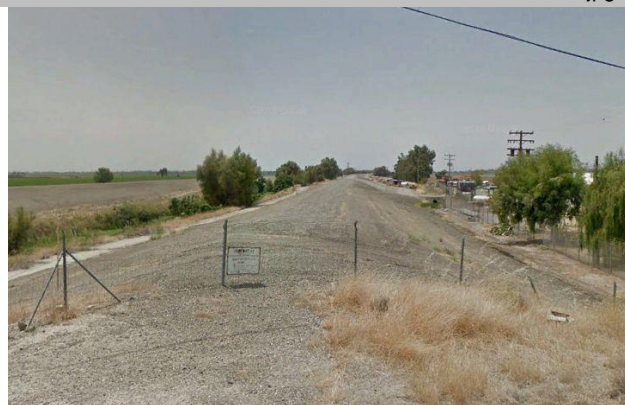
Photo 1 of 1 : SP_2016_ST0010_43_20_20160517_00032.jpg

LM Start	2.39	Rating **	A	Issue No.	20
LM End	2.39	Issue Type +	Ma	Location *	LS
Category	Earthen Levee			GPS Latitude/Longitude	
				Start	End
Item	Vegetation			39.142053 °	39.142053 °
				-121.743316 °	-121.743316 °
DWR ID	DWR_ST0010_02_s_2016_20				
Comment Code					
V1 : Control annual grass and weeds on the levee slopes and easements.					
Inspector Comment					
Vegetation maintained to minimal level.

3/17/2016: Vegetation maintained to acceptable level.

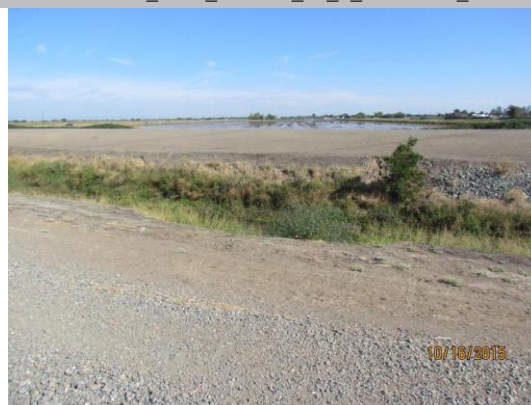
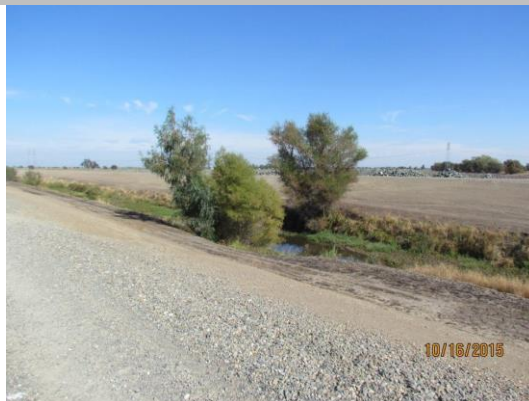
LM Start	2.41	Rating **	M	Issue No.	8
LM End	3.28	Issue Type +	Ma	Location *	WS
Category	Supplemental			GPS Latitude/Longitude	
				Start	End
Item	2015 USACE Erosion Survey, DRAFT			39.142254 °	39.153150 °
				-121.742847 °	-121.734611 °
DWR ID	DWR_ST0010_02_s_2016_8				
Comment Code					
Inspector Comment					
2010 - Over steepened levees, some slumping, reach-wide problem. 2011 - Still a reach-wide problem. 2015: Site is part of the extended inventory, last inspected 2011. [2015 Site ID: WAD_2-4_R]

View of erosion along the waterside toe.

View of the erosion along the landside toe.

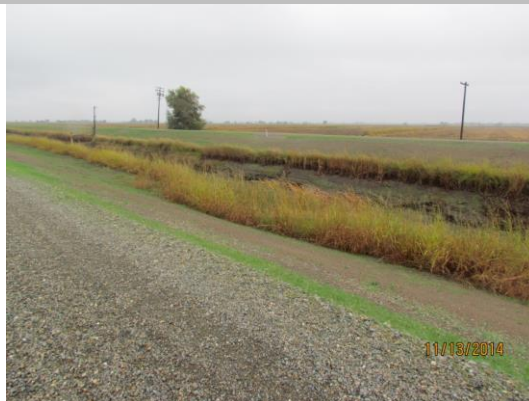
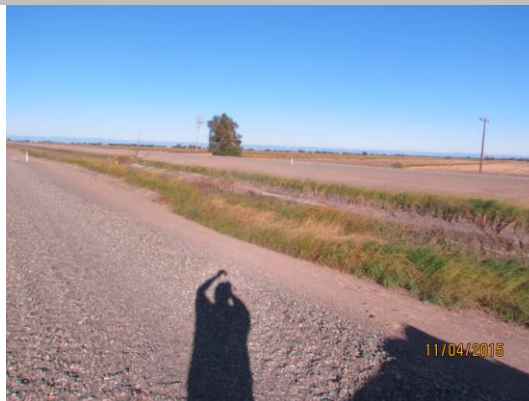
LM Start	3.42	Rating **	M	Issue No.	4
LM End	3.42	Issue Type +	Ma	Location *	WS
Category	Earthen Levee			GPS Latitude/Longitude	
				Start	End
Item	Erosion / Bank Caving			39.155057 °	39.155057 °
				-121.733985 °	-121.733985 °
DWR ID	DWR_ST0010_02_s_2012_4				
Comment Code					
E1 : Note and monitor erosion site.					
Inspector Comment					
Monitor the erosion at the waterside toe.

View of the erosion at the waterside toe.

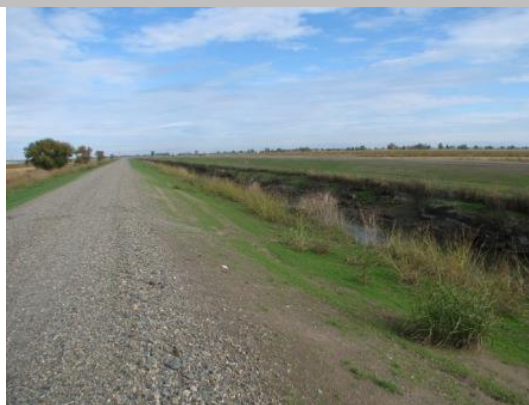
LM Start	3.54	Rating **	M	Issue No.	5
LM End	3.93	Issue Type +	Ma	Location *	WS
Category	Earthen Levee			GPS Latitude/Longitude	
				Start	End
Item	Erosion / Bank Caving			39.156753 °	39.162113 °
				-121.733267 °	-121.730997 °
DWR ID	DWR_ST0010_02_s_2012_5				
Comment Code					
E1 : Note and monitor erosion site.					
Inspector Comment					
Monitor is the erosion at the waterside toe.

View of the erosion along the waterside toe.

View of erosion at the waterside toe

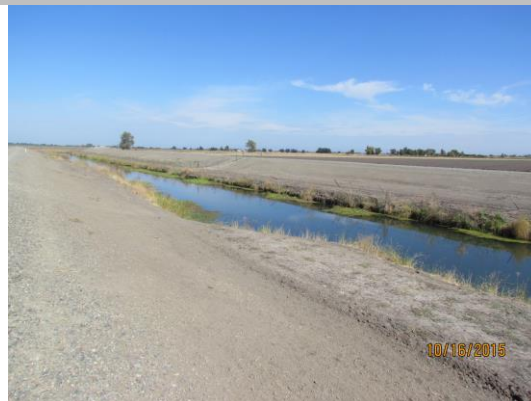
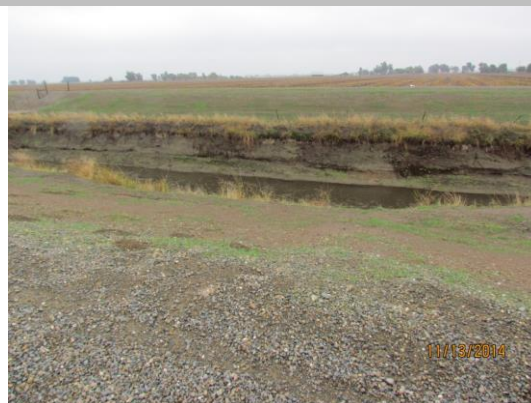
LM Start	4.41	Rating **	M	Issue No.	9
LM End	4.43	Issue Type +	Ma	Location *	WS
Category	Supplemental			GPS Latitude/Longitude	
				Start	End
Item	2015 USACE Erosion Survey, DRAFT			39.168659 °	39.168937 °
				-121.728016 °	-121.727905 °
DWR ID	DWR_ST0010_02_s_2016_9				
Comment Code					
Inspector Comment					
2011 - Small erosion pocket. 2015: Site is part of the extended inventory, last inspected 2011. [2015 Site ID: WAD_4-3_R]

View of the erosion along the waterside toe.

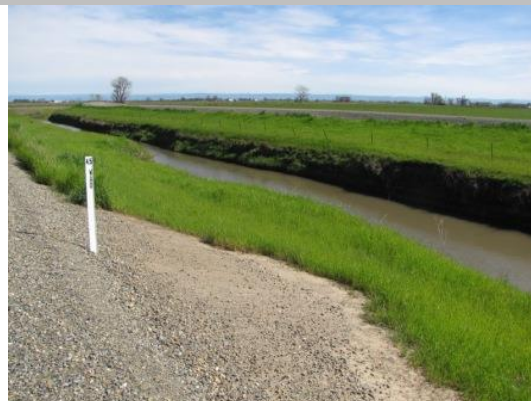
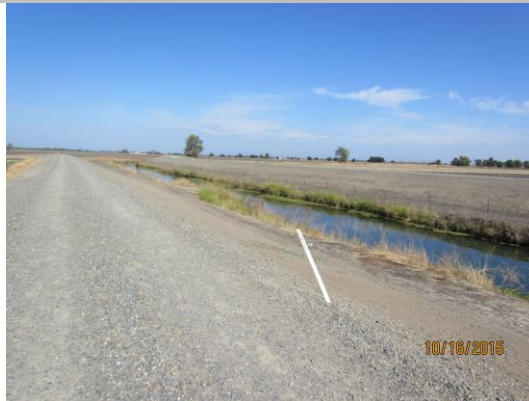
LM Start	4.48	Rating **	M	Issue No.	7
LM End	4.48	Issue Type +	Ma	Location *	WS
Category	Earthen Levee			GPS Latitude/Longitude	
				Start	End
Item	Erosion / Bank Caving			39.169670 °	39.169670 °
				-121.727787 °	-121.727787 °
DWR ID	DWR_ST0010_02_s_2012_7				
Comment Code					
E1 : Note and monitor erosion site.					
Inspector Comment					
Monitor the erosion along the waterside toe.

View of the erosion along the W/S toe.

View of the erosion along the waterside toe.
